ACOUSTIC EFFECTS OF MARINE FOULING ON TRANSDUCERS

21 NOVEMBER 1962

UNITED STATES NAVAL ORDNANCE LABORATORY, WHITE OAK, MARYLAND

NOLTR 62-185

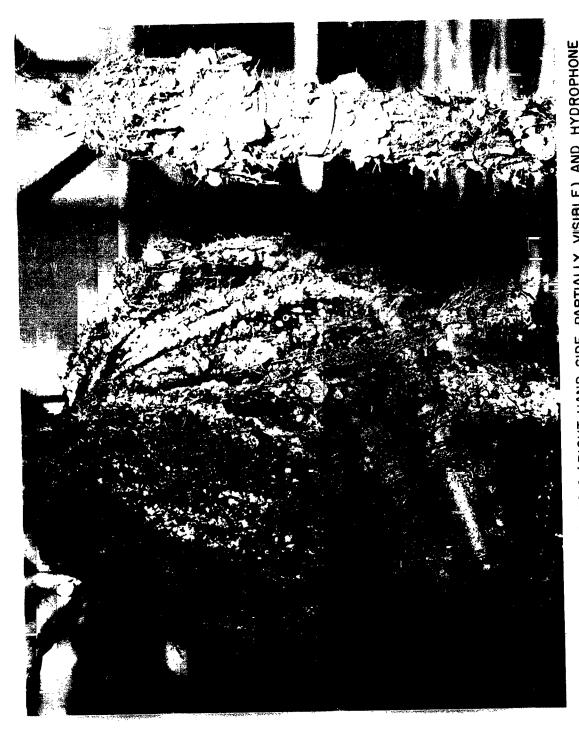
Description of Fouling: 10% of the surface area was covered with barnacles, and 10% area was covered with hydroids (Bryozoans, sea squirts). Remainder of transducer face unfouled. Brass top cap, however, was completely fouled.

Description of Fouling: Unit was only slightly fouled. Approximately 10% of area was covered by barnacles, with a 5 - 15% covering of sea squirts.

HYDROPHONE NO.2 (RIGHT HAND SIDE, PARTIALLY VISIBLE) AND HYDROPHONE NO.4 (LEFT HAND SIDE, CLUSTER OF UNITS), FOULED. F16. 7

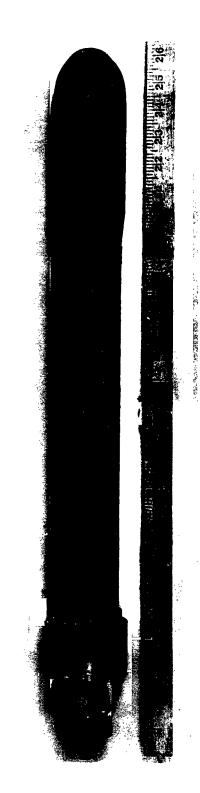
FIG. 8 HYDROPHONE NO.2, CLEANED. SENSITIVE PORTION AT BOTTOM; REMAINDER IS A PRE-AMPLIFIER.

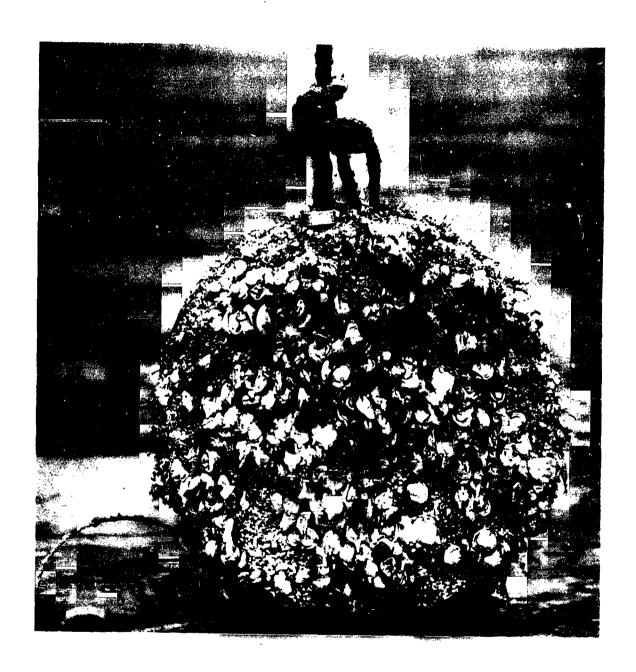
Description of Fouling: Face covered almost completely with small barnacles 5-6 mm diameter (Balanus improvisus), on top of which were large sea squirts. Large patches of dead barnacles are evident in the photograph.

FIG. 12 HYDROPHONE NO.3, FOULED

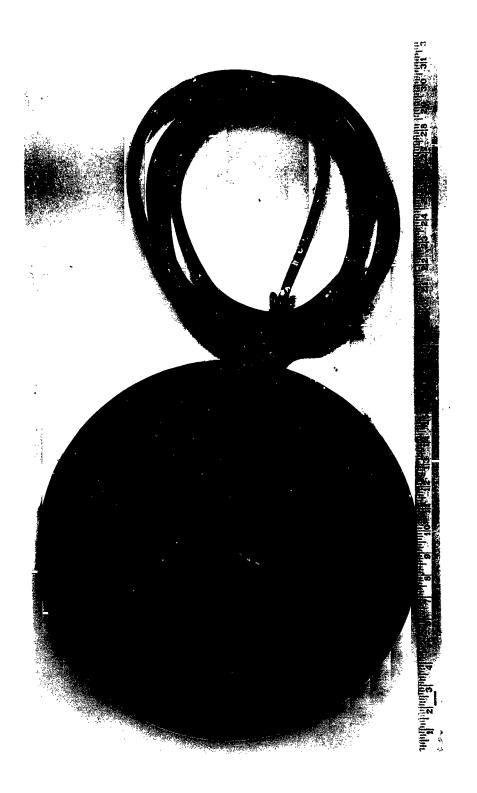
FIG. 13 HYDROPHONE NO. 3, CLEANED
